Manhole Inspection Summary

Manhole # S25GG2008MH

Insp Date: 11/15/06 1:59 PM

Location Address: **806 BELLMORE RD**

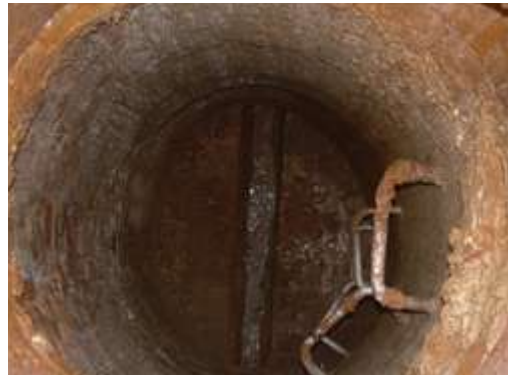
Top View

Frame leaks. Adjustment deterioration and infiltration. Bench debris.

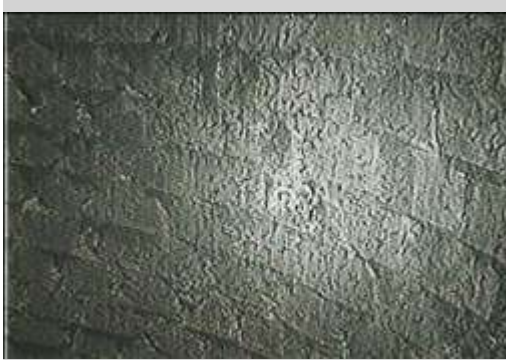
Defect

Barrel deterioration and infiltration.

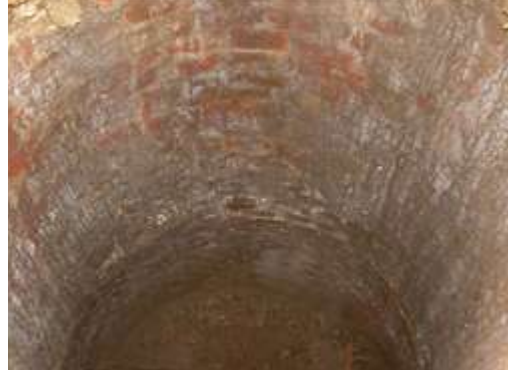
Defect

Adjustment and Barrel infiltration.

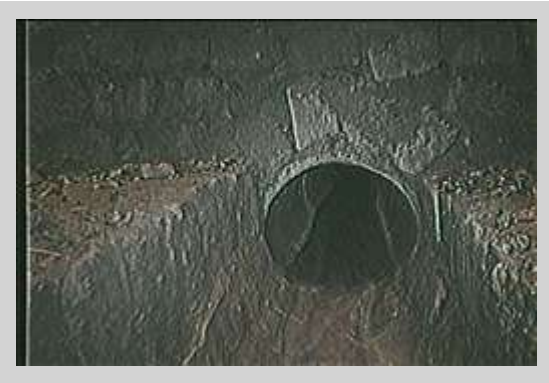
8 in. Circular Gravity Sewer Pipe Out @ 12 O'Clock

Pipe Material: **Clay** ☐ Pipe Lined

Invert Depth: **9.82** (ft.) Flow Characteristics: **Fast**

Infiltration: **None** Pipe Seal Cond: **Unknown**

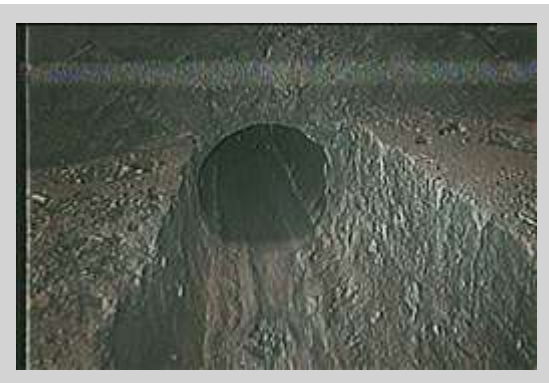
8 in. Circular Gravity Sewer Pipe In @ 6 O'Clock

Pipe Material: **Clay** ☐ Pipe Lined

Invert Depth: **9.58** (ft.) Flow Characteristics: **Fast**

Infiltration: **None** Pipe Seal Cond: **Cracked**
